IP TEST REPORT

Project No.: L10-70077

Equipment Under Test: LED-SMD Lighting (300 W)

Tested According to: IEC 60529 2013/COR1:2019 AND IEC 60598-1 2020

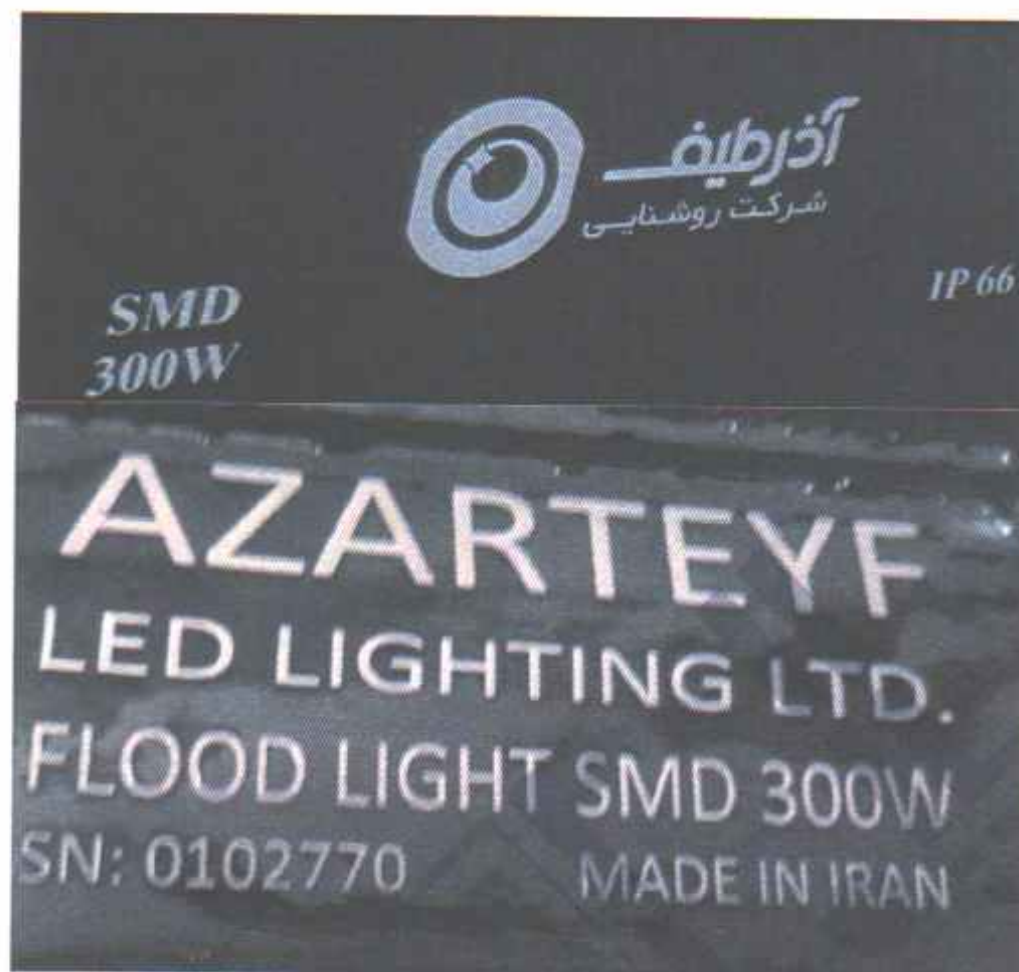
2.1. Marking:

Test was done according to IEC 60598-1, sub clause 3 and it passed the test.

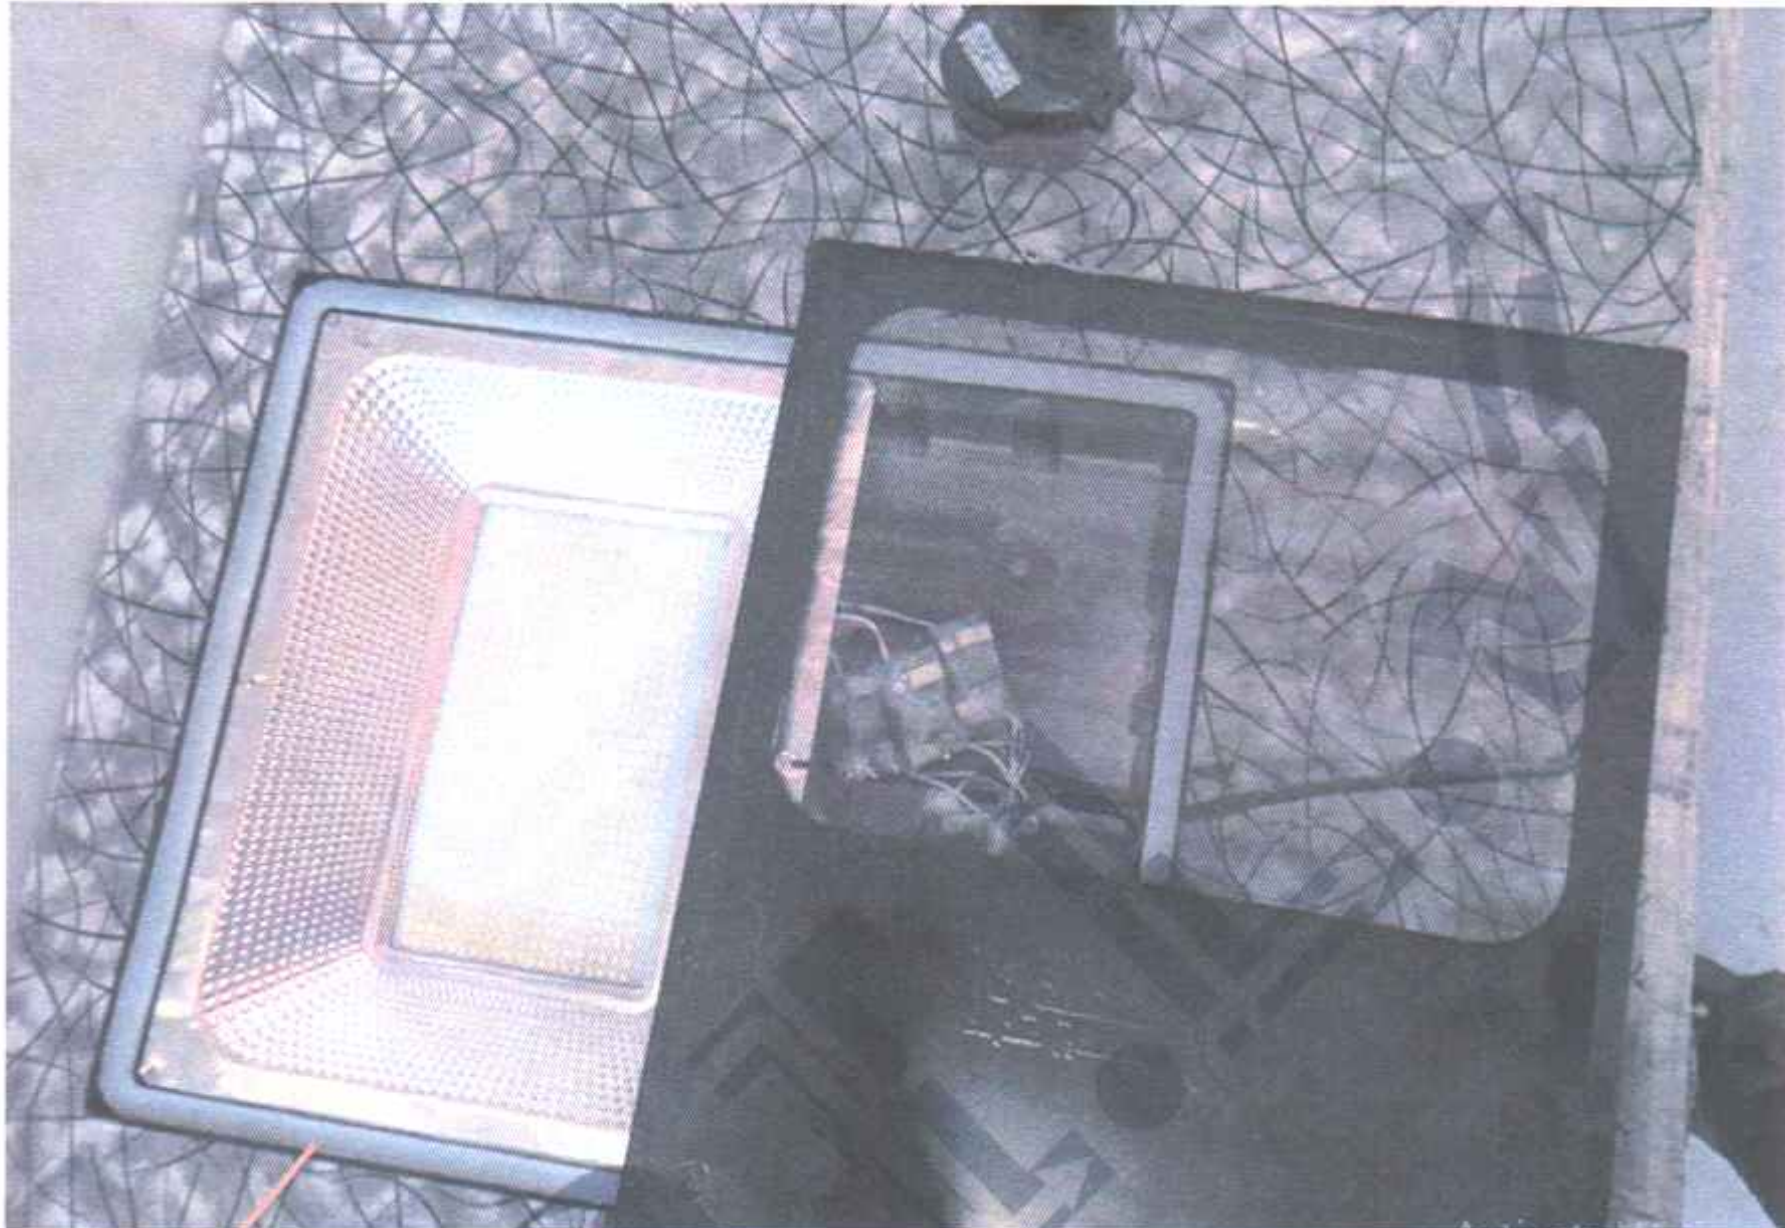
Figure 4: EUT after IPX6

Note : (Gasket was used in the EUT for sealing)

After testing the EUT shall be inspected for no trace of water on current-carrying parts or SELV parts where the voltage under load exceeds 12 V r.m.s. or 30 V ripple-free d.c. or on insulation where it could become a hazard for the user or surroundings, for example, where it could reduce the creepage distances below the values specified in Section 11 specified in IEC 60598.

Test was done according to IEC 60598-1 and it passed the test.
